Situation Photo Log

Thursday, January 24, 2013

Kalamazoo River / Enbridge Spill

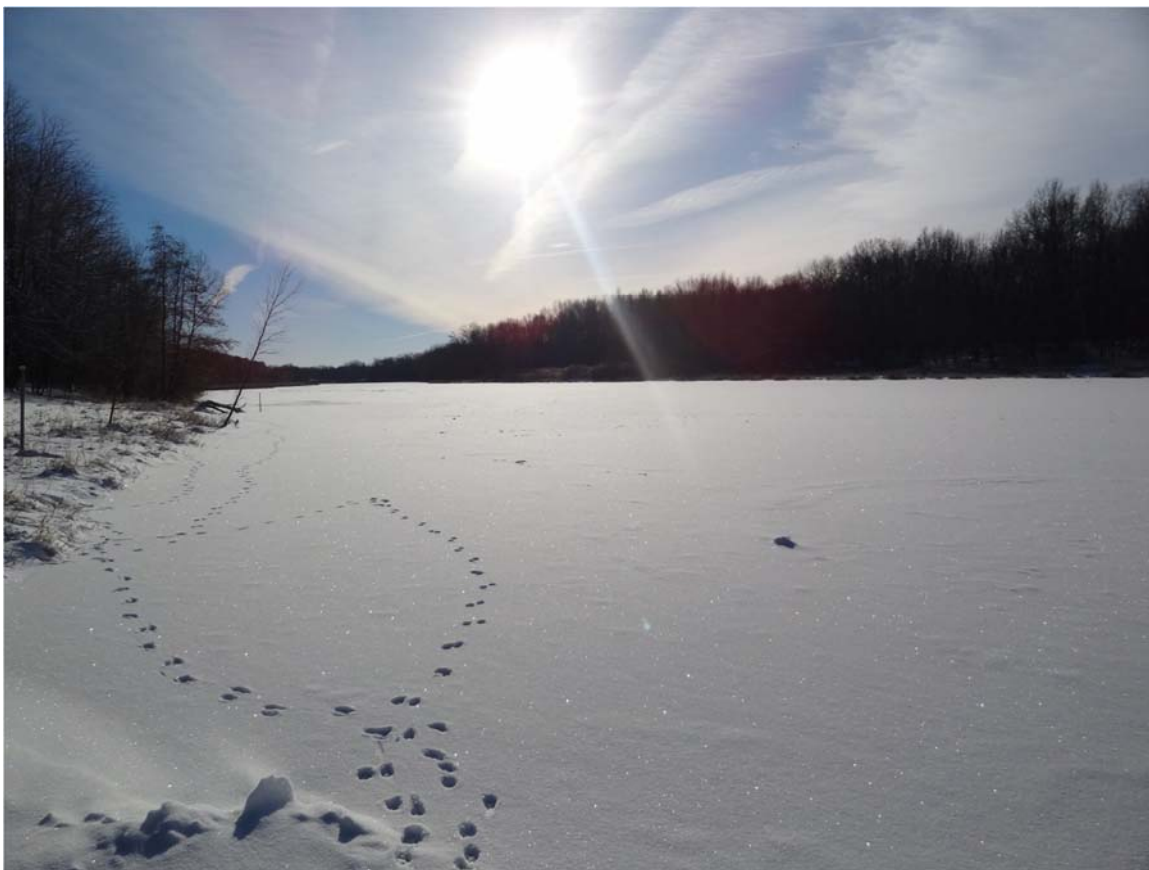
1. C0.4 Boat launch observed river icing conditions.

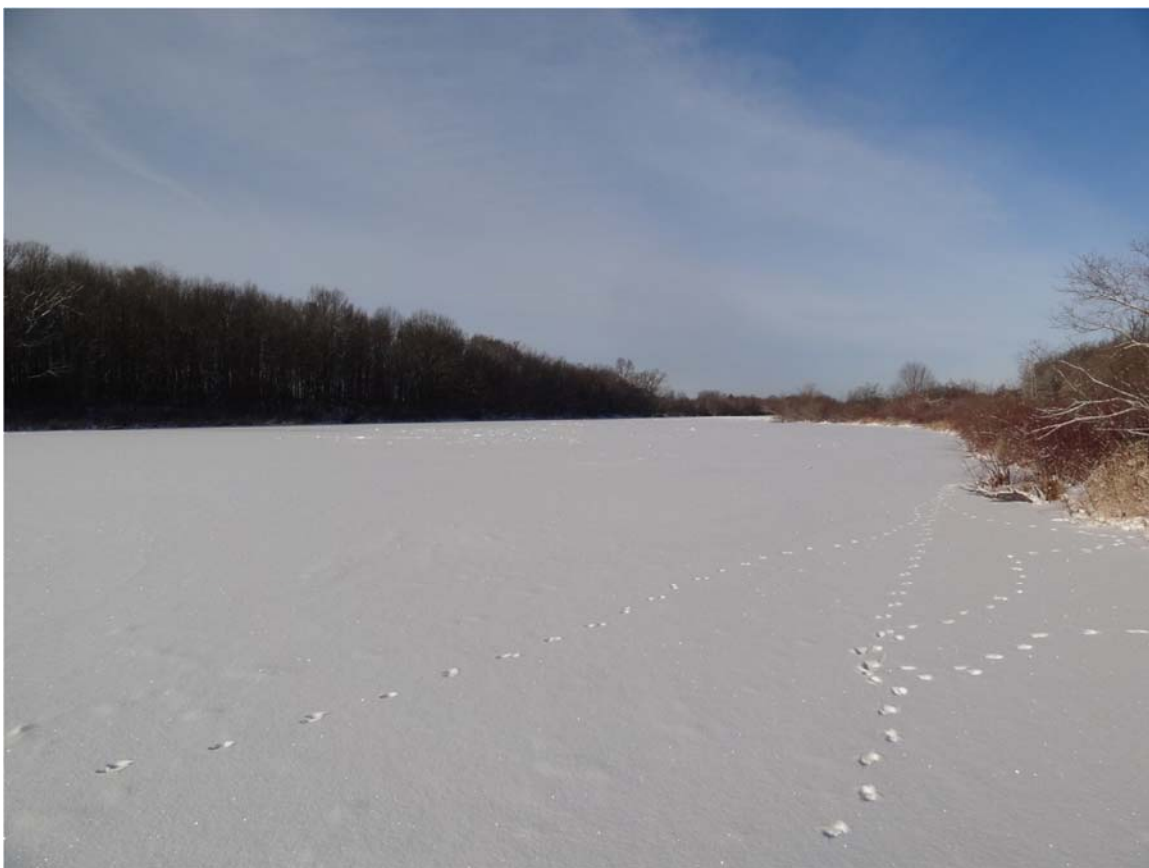
2. C0.4 Boat launch observed river icing conditions.

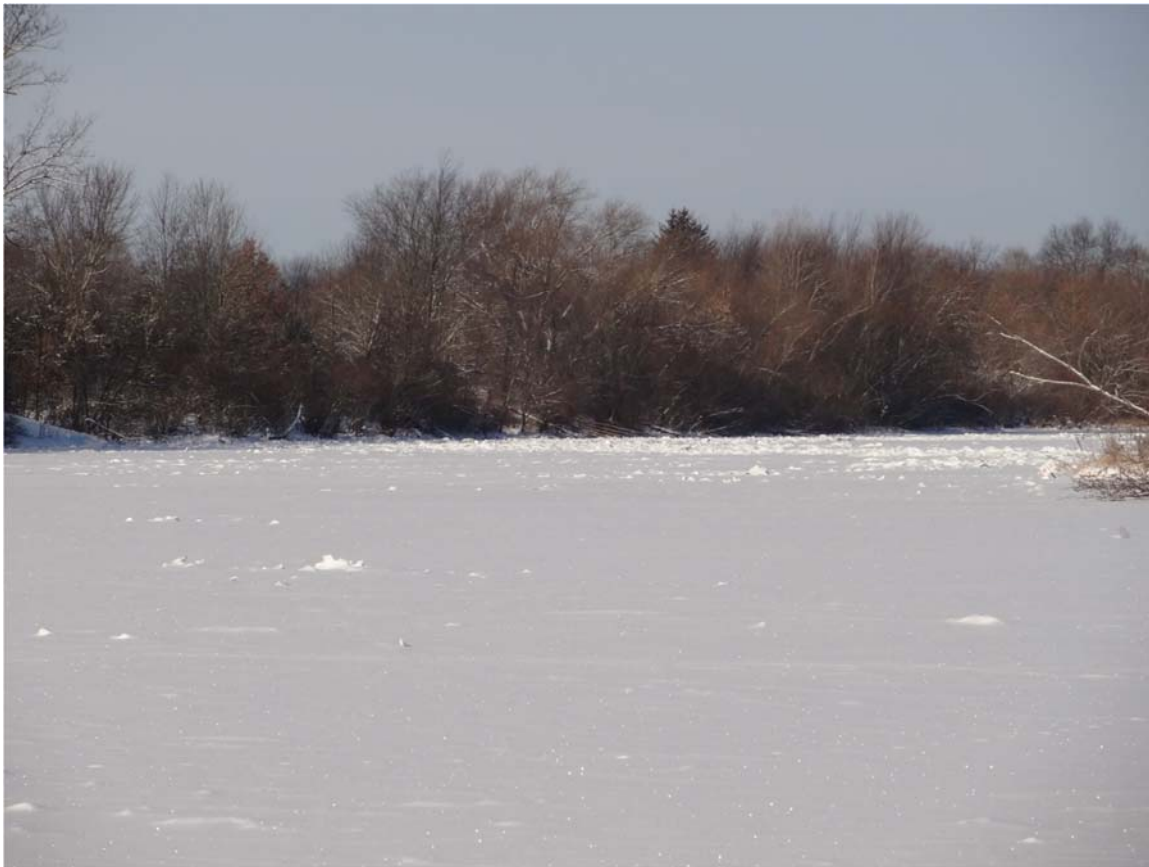
3. MP5.25 C0.4 observed river icing conditions.

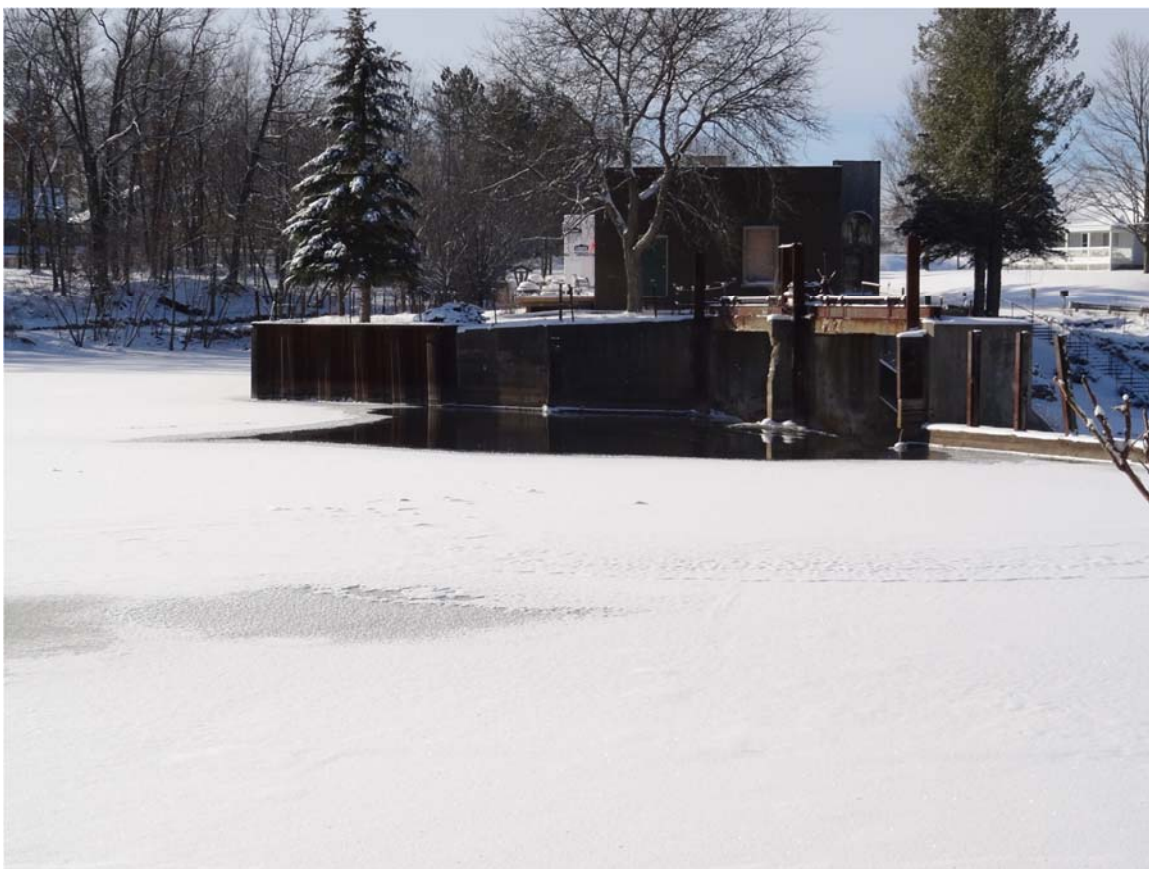
4. Ceresco Dam impoundment observed river icing conditions.

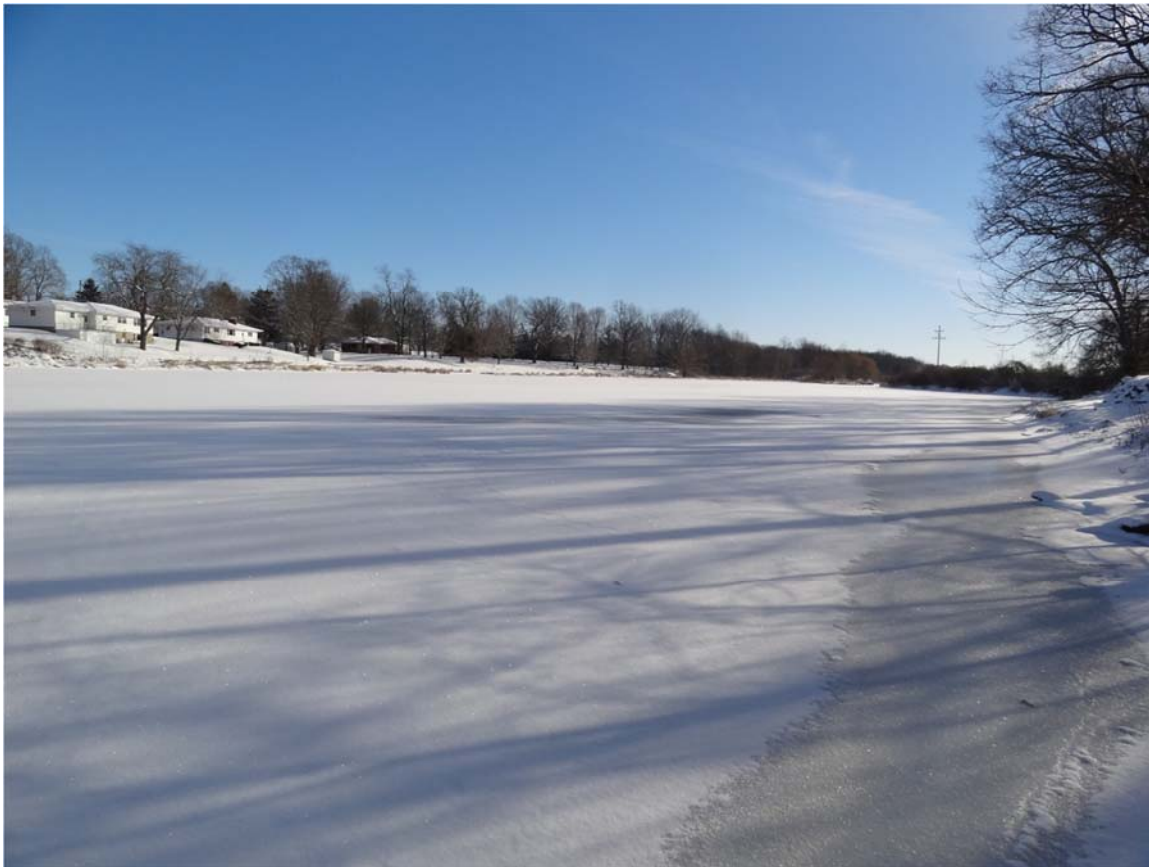
5. Ceresco Dam impoundment observed river icing conditions.

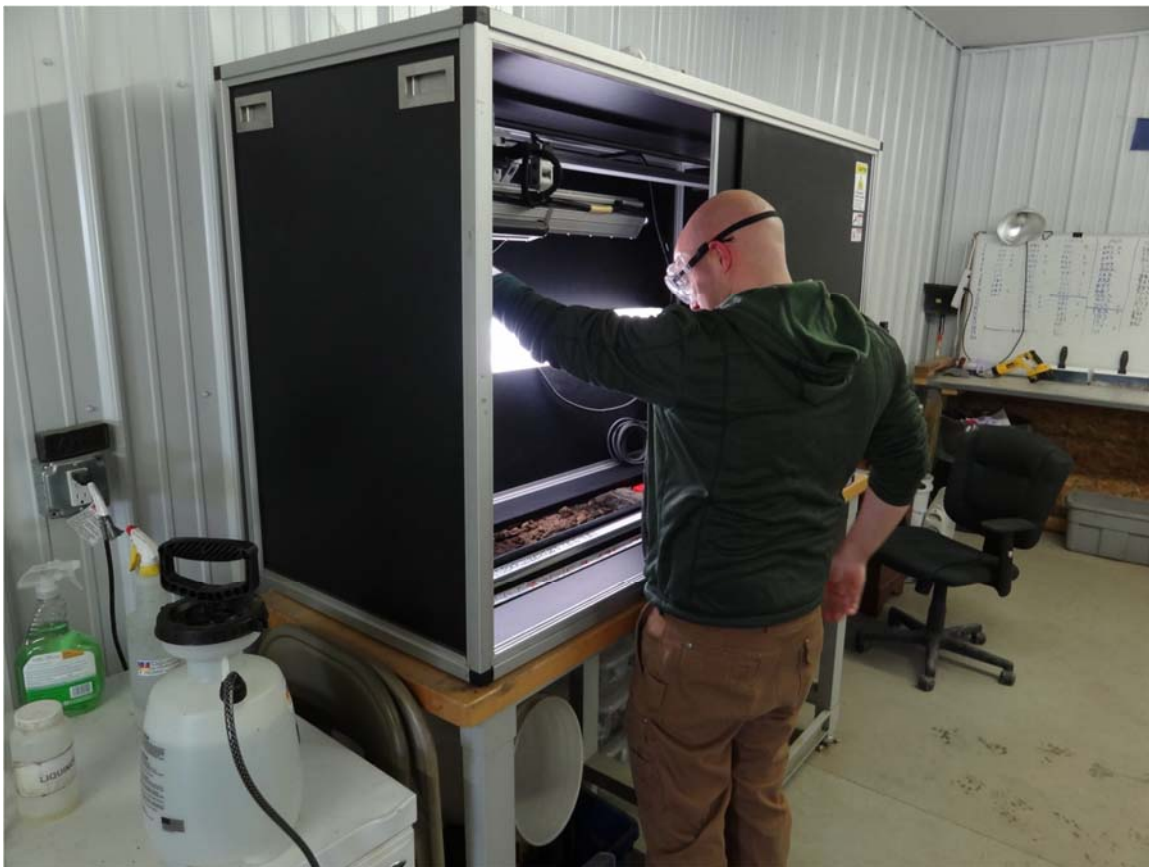
6. C3.2 Pole Barn observed core logging operations.

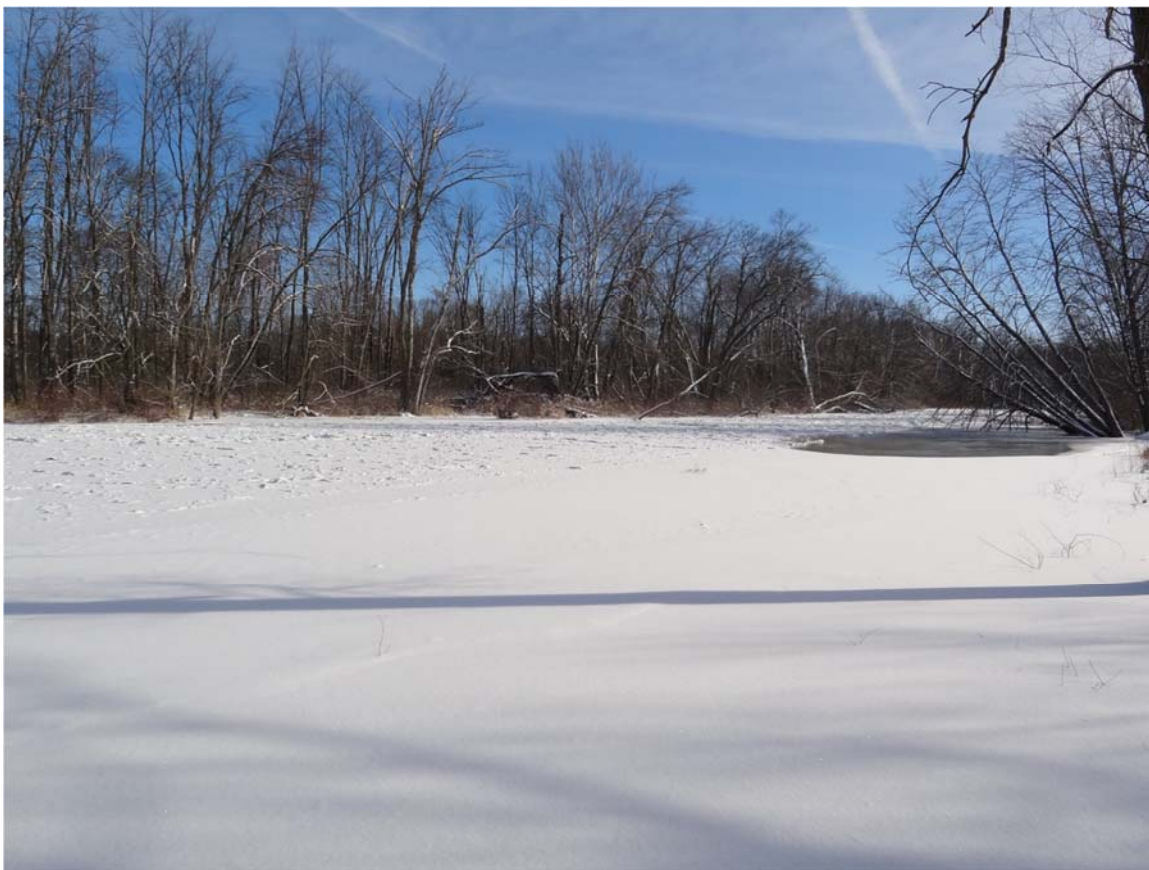
7. C3.2 Boat launch observed river icing conditions.

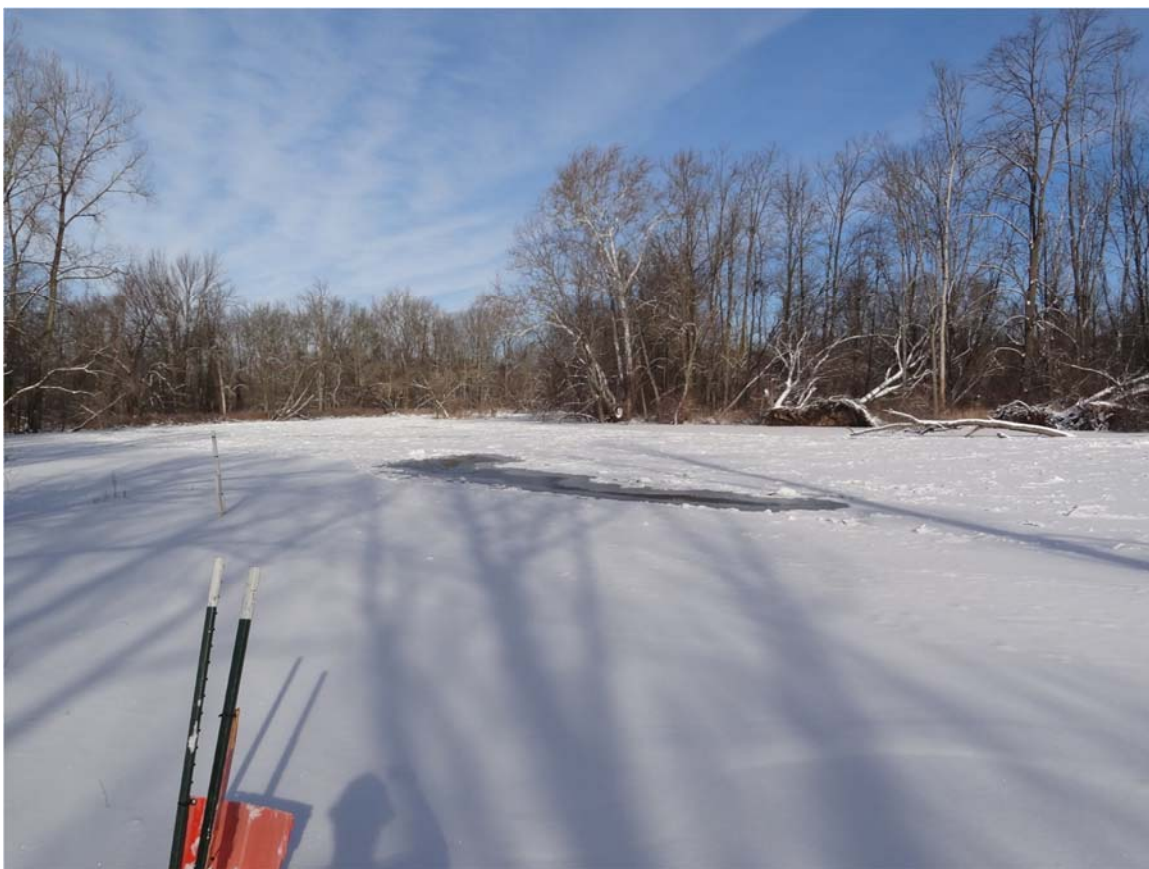
8. C3.2 Boat launch observed river icing conditions.

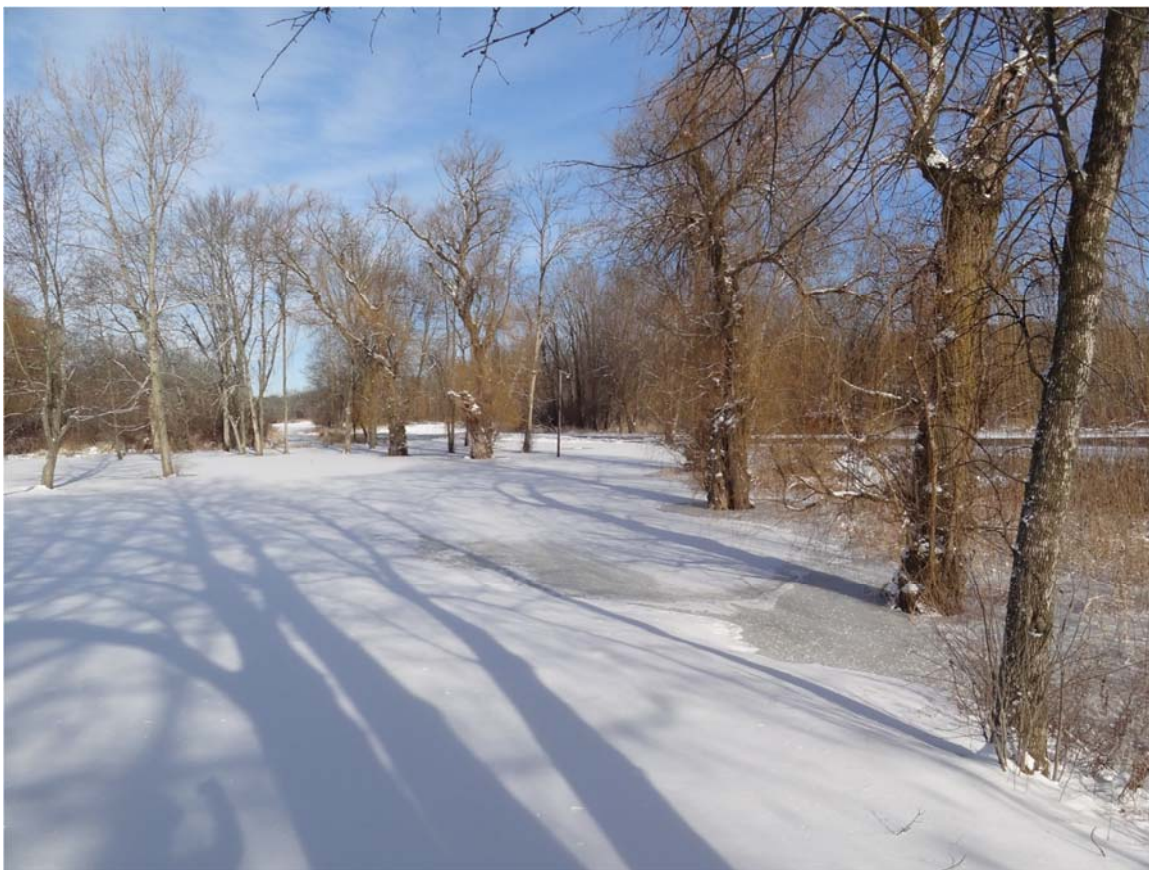
9. MP10.35 Observed river icing conditions.

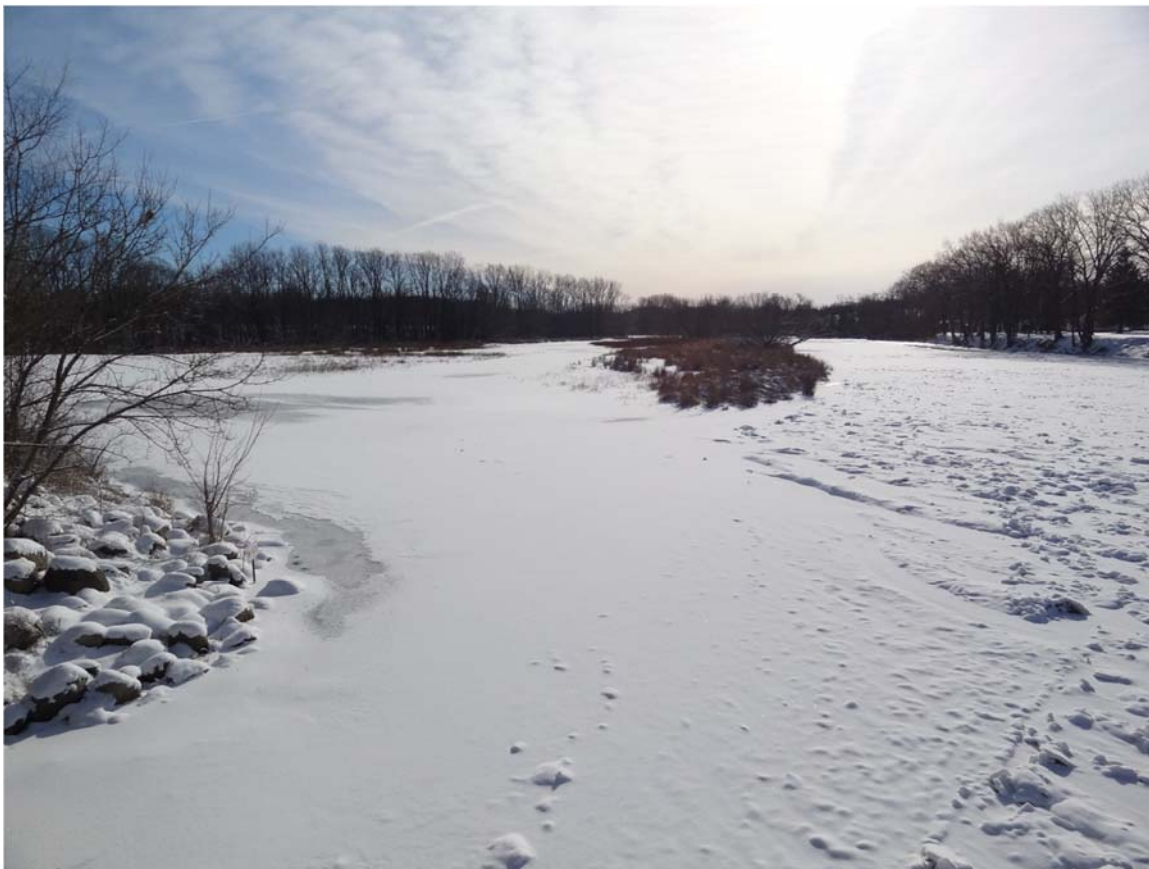
10. MP15.25 South Mill Pond observed river icing conditions.

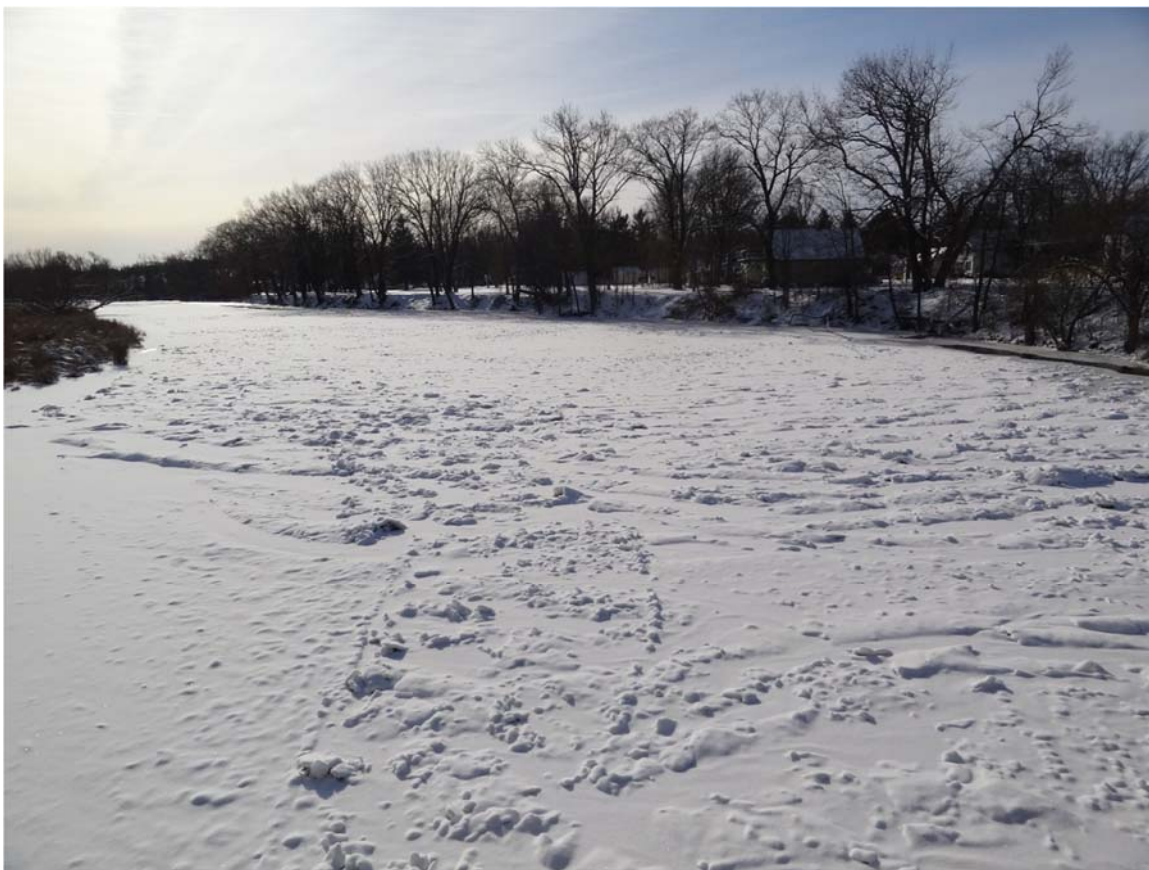
11. MP15.25 South Mill Pond observed river icing conditions.

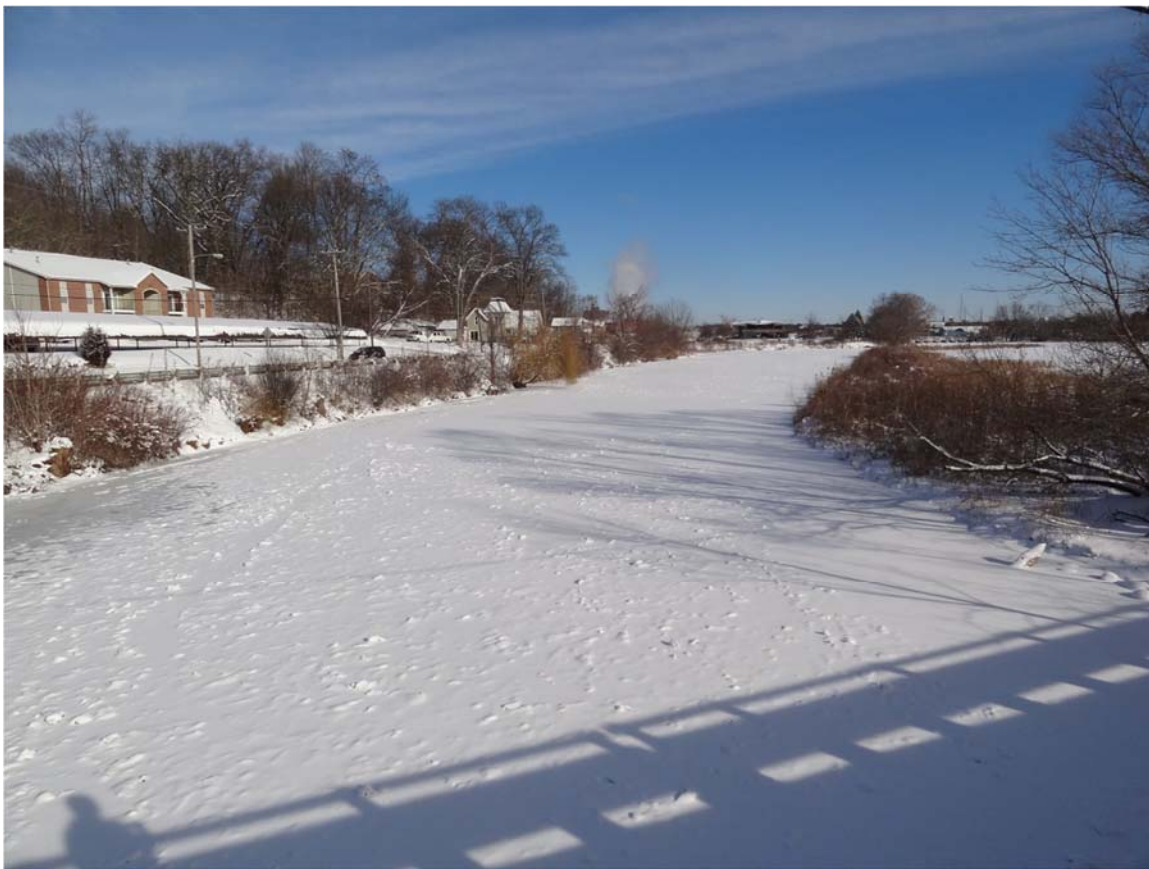
12. MP15.5 North Mill Pond observed river icing conditions.

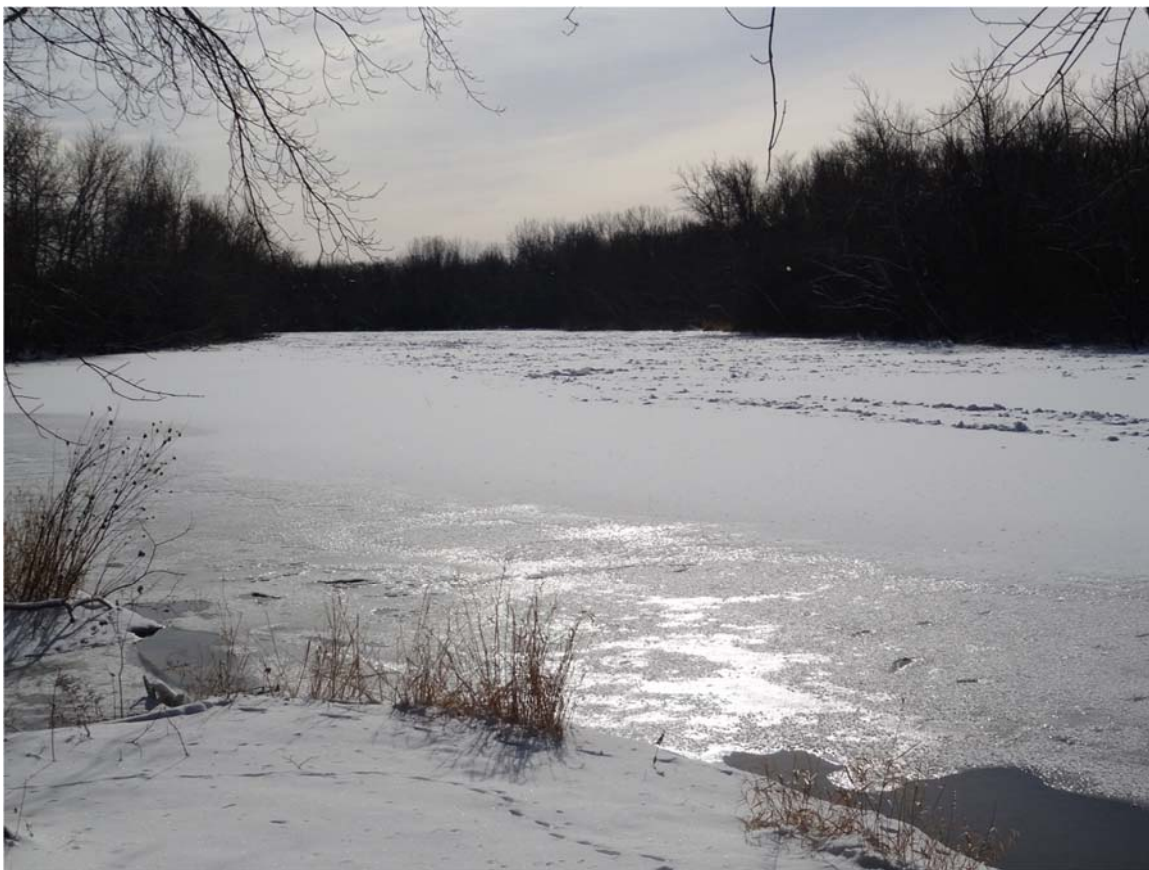
13. MP19.25 observed river icing conditions.

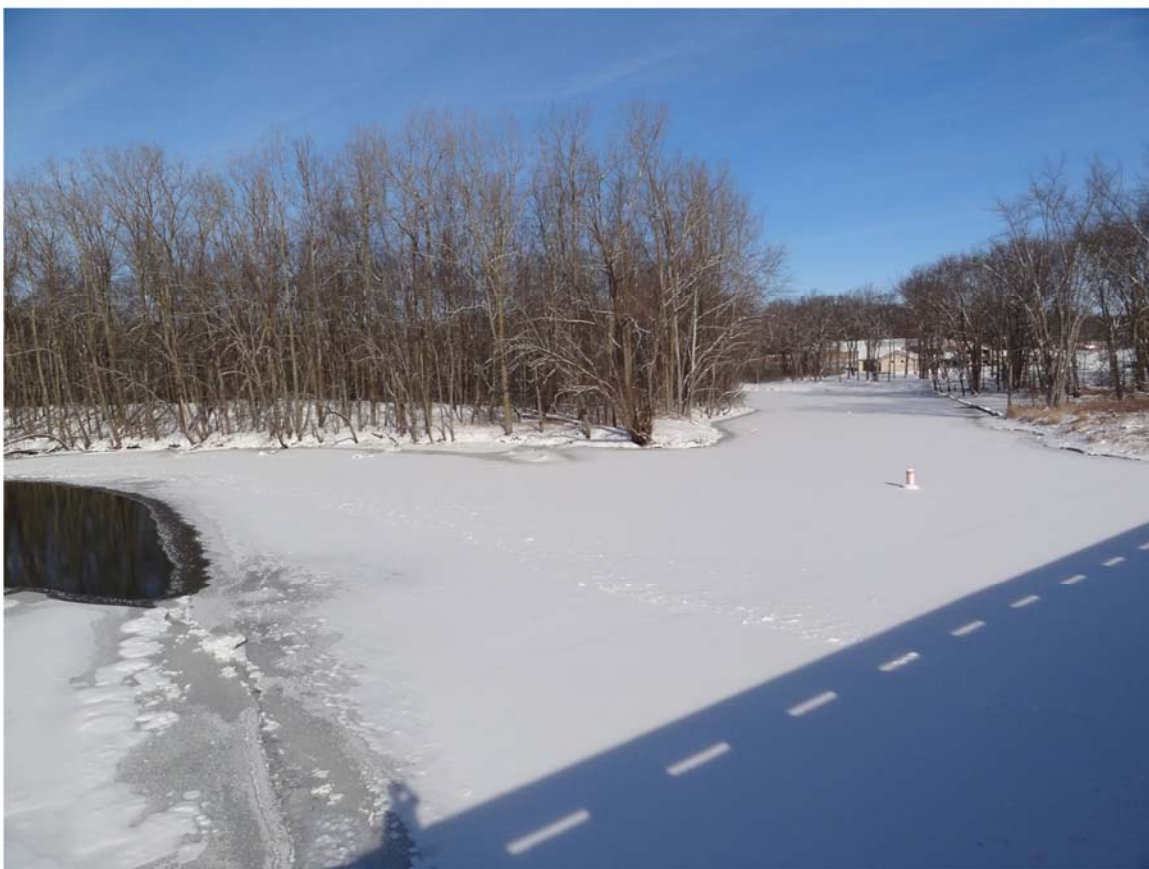
14. MP21.5 observed the oxbow river icing conditions.

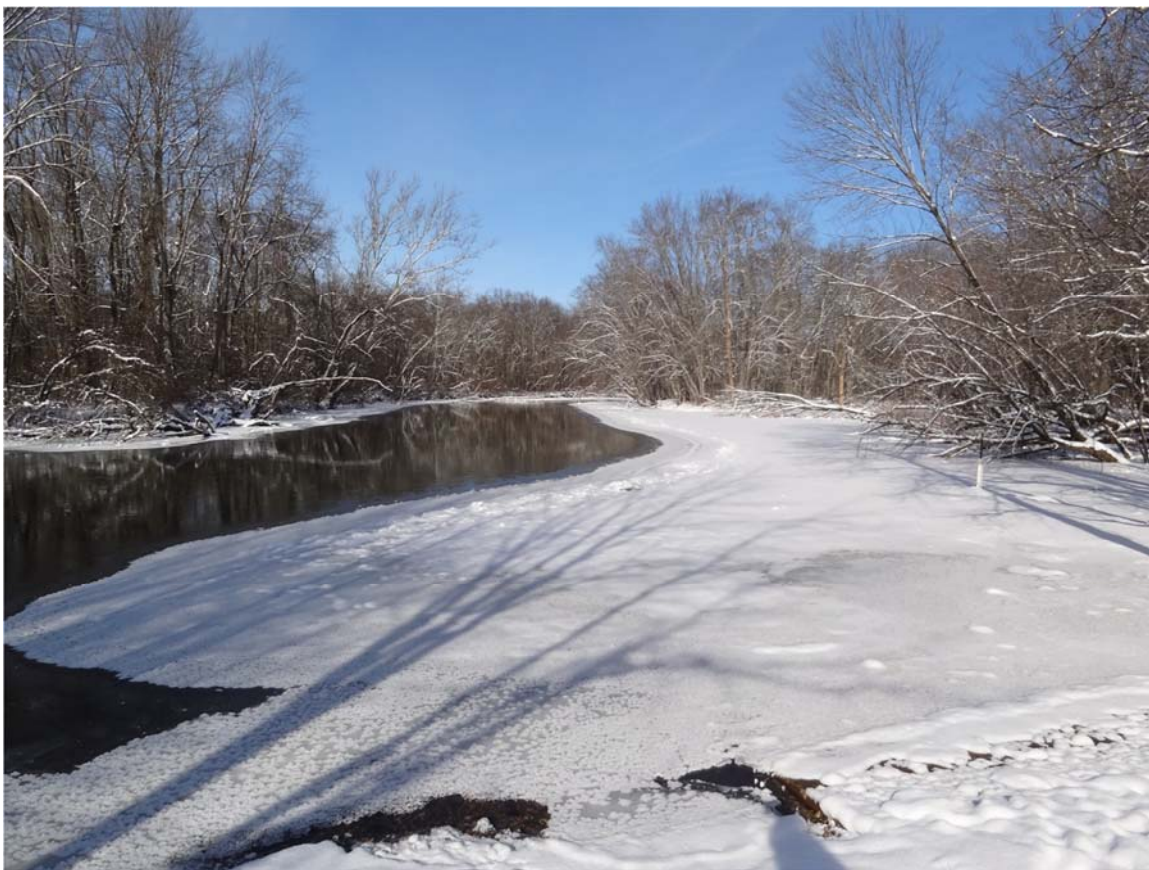
15. E2 Boat launch observed river icing conditions.

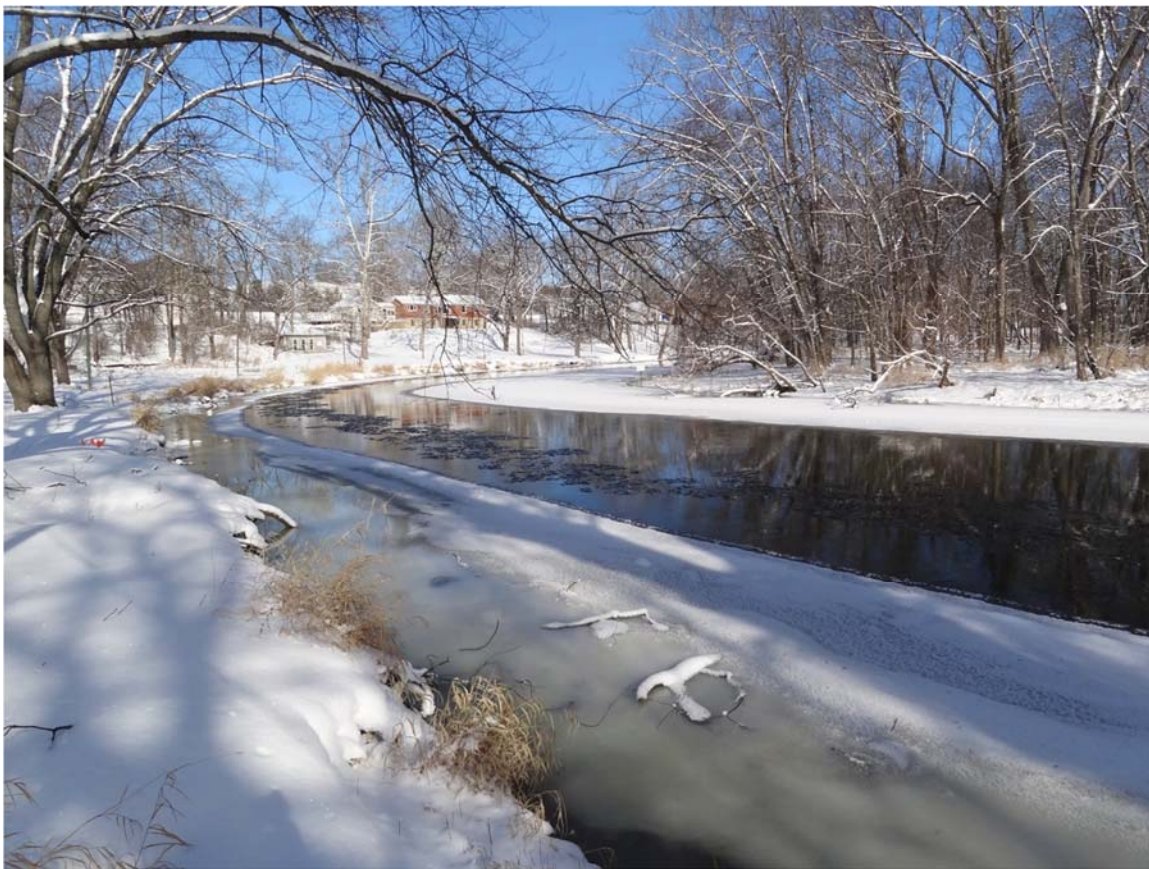
16. MP27.0 E0.5 Boat launch observed river icing conditions.

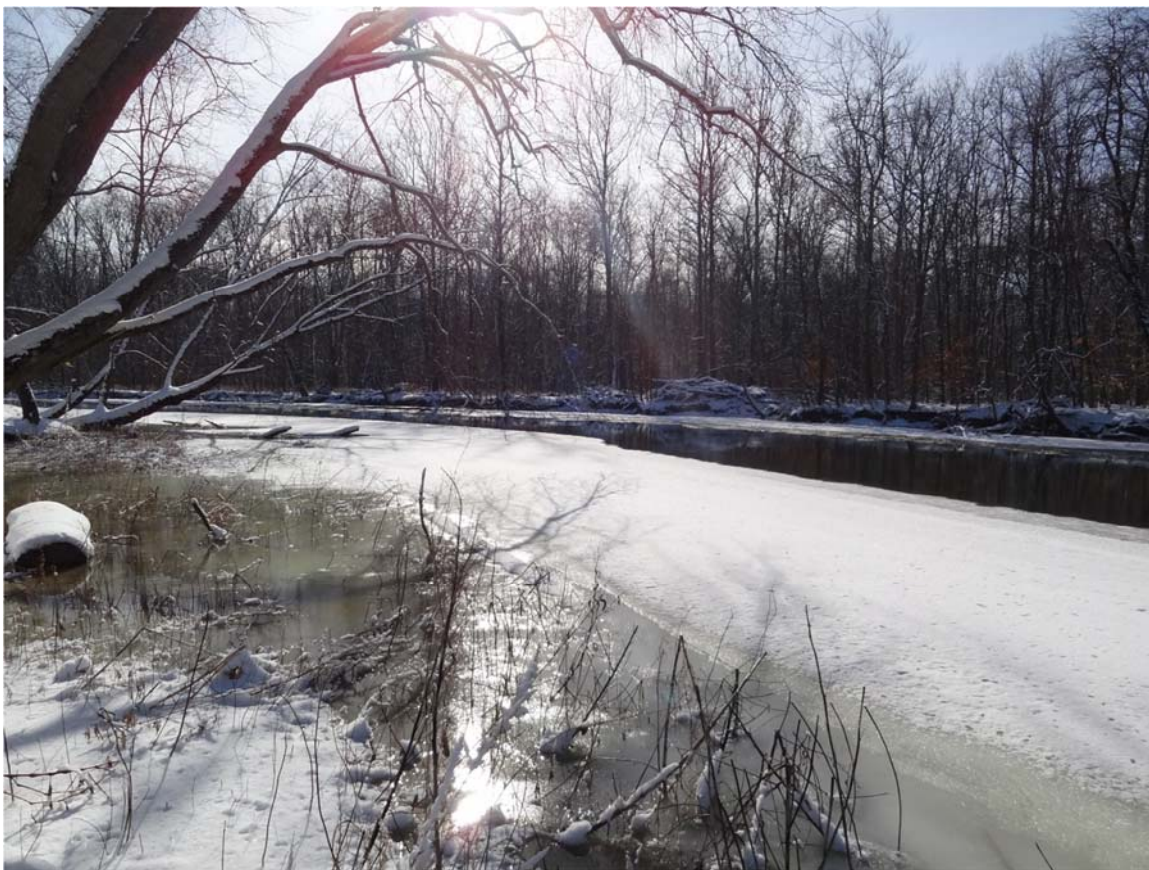
17. MP27.0 E0.5 Boat launch observed river icing conditions.

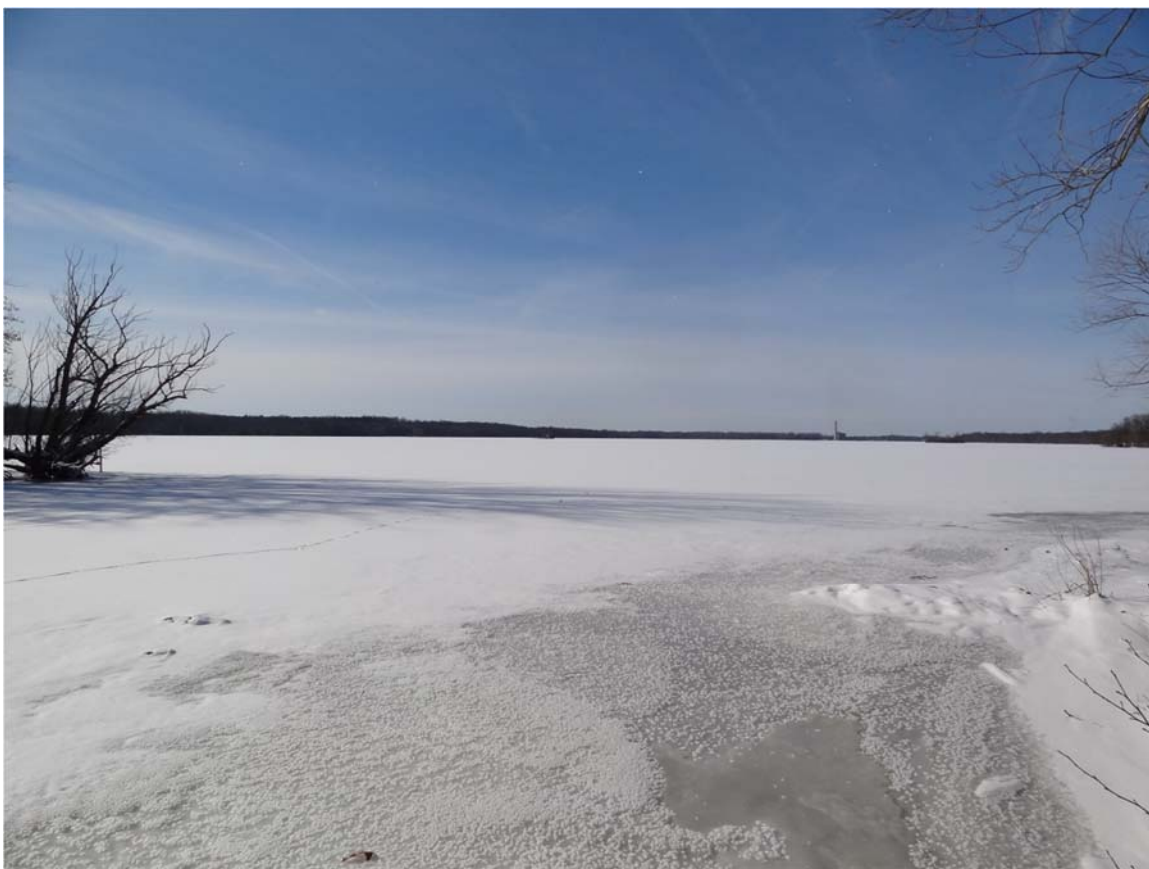
18. Morrow Lake observed icing conditions.

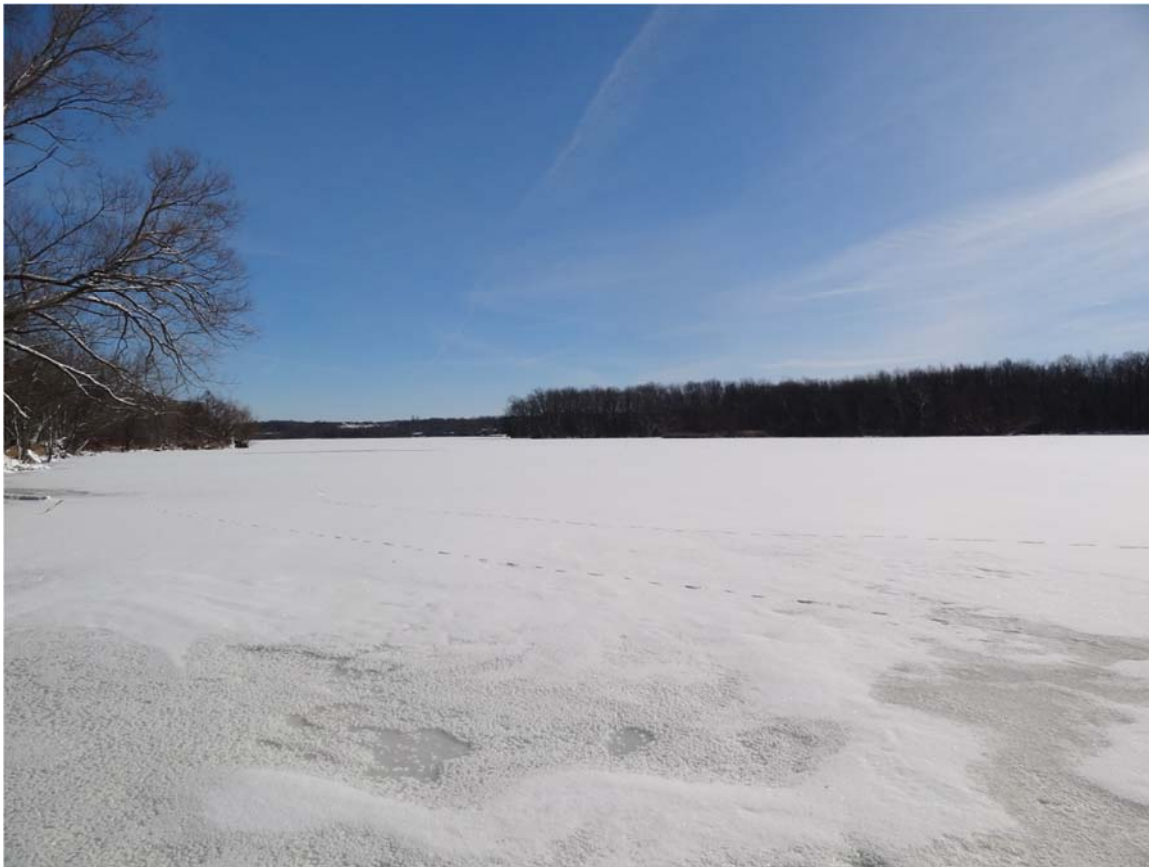
19. Morrow Lake Neck/Morrow Lake Delta observed icing conditions.

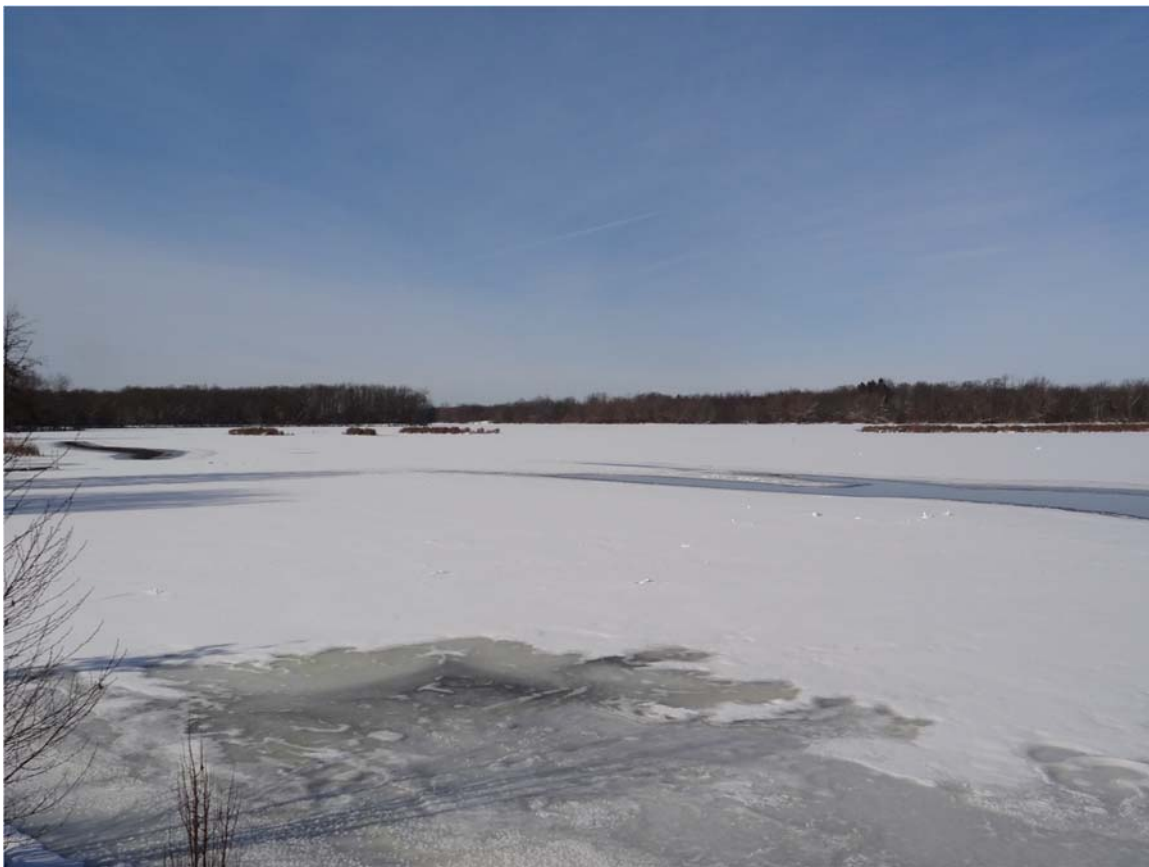
20. Morrow Lake Delta observed icing conditions.

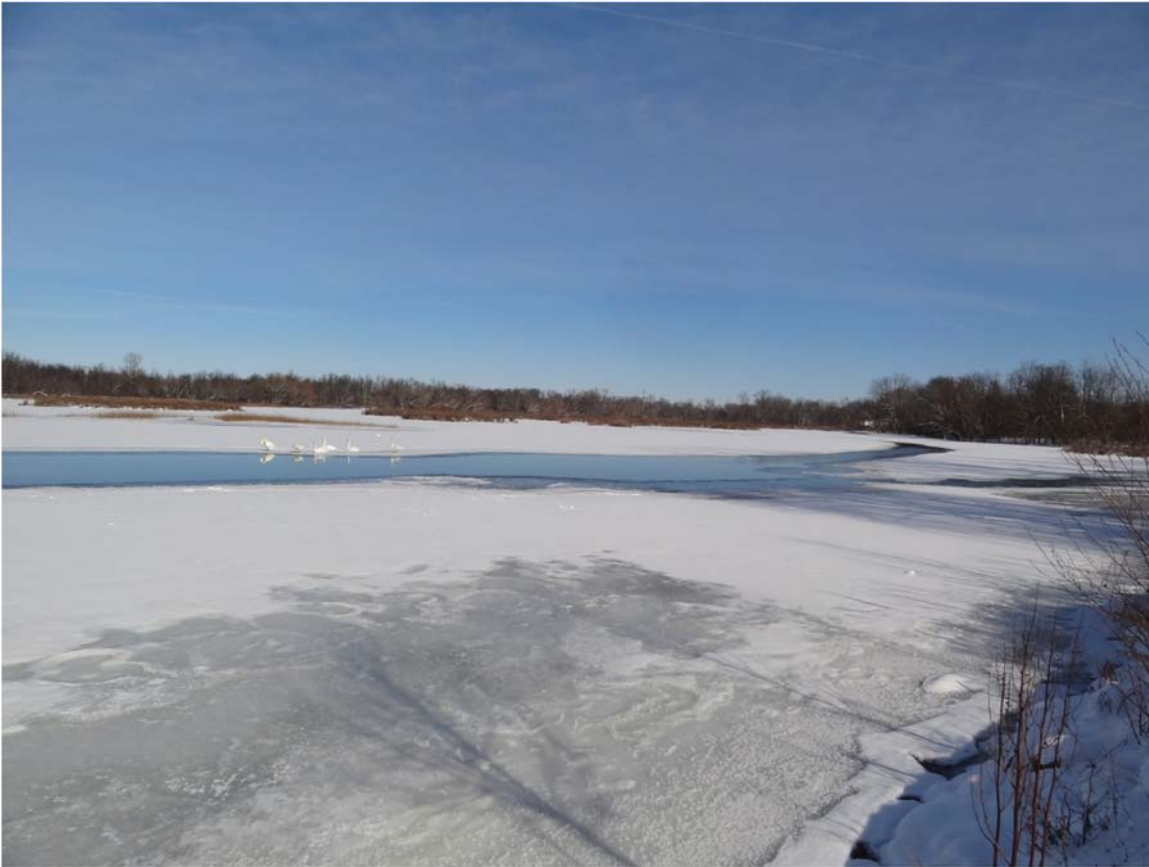
21. Morrow Lake Delta observed icing conditions.

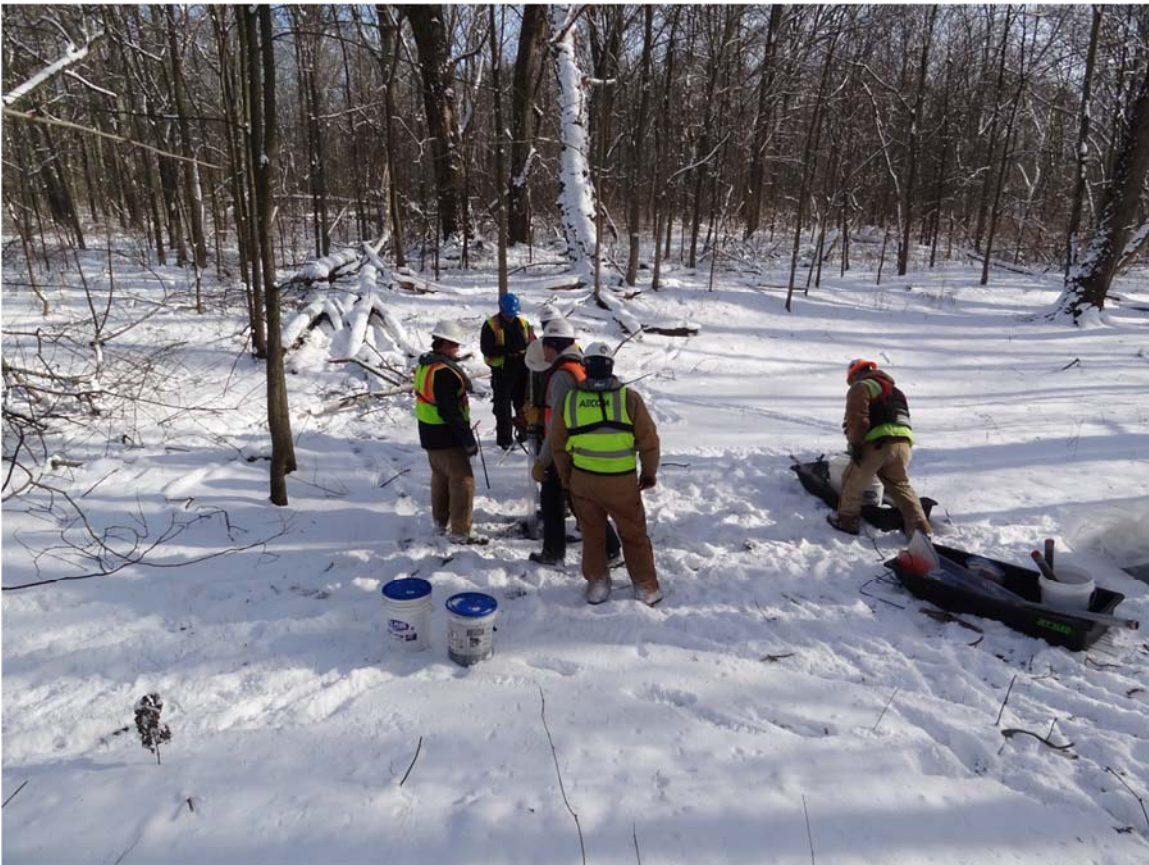
22. MP21.25 RDB overbank oxbow observed the RI crew.

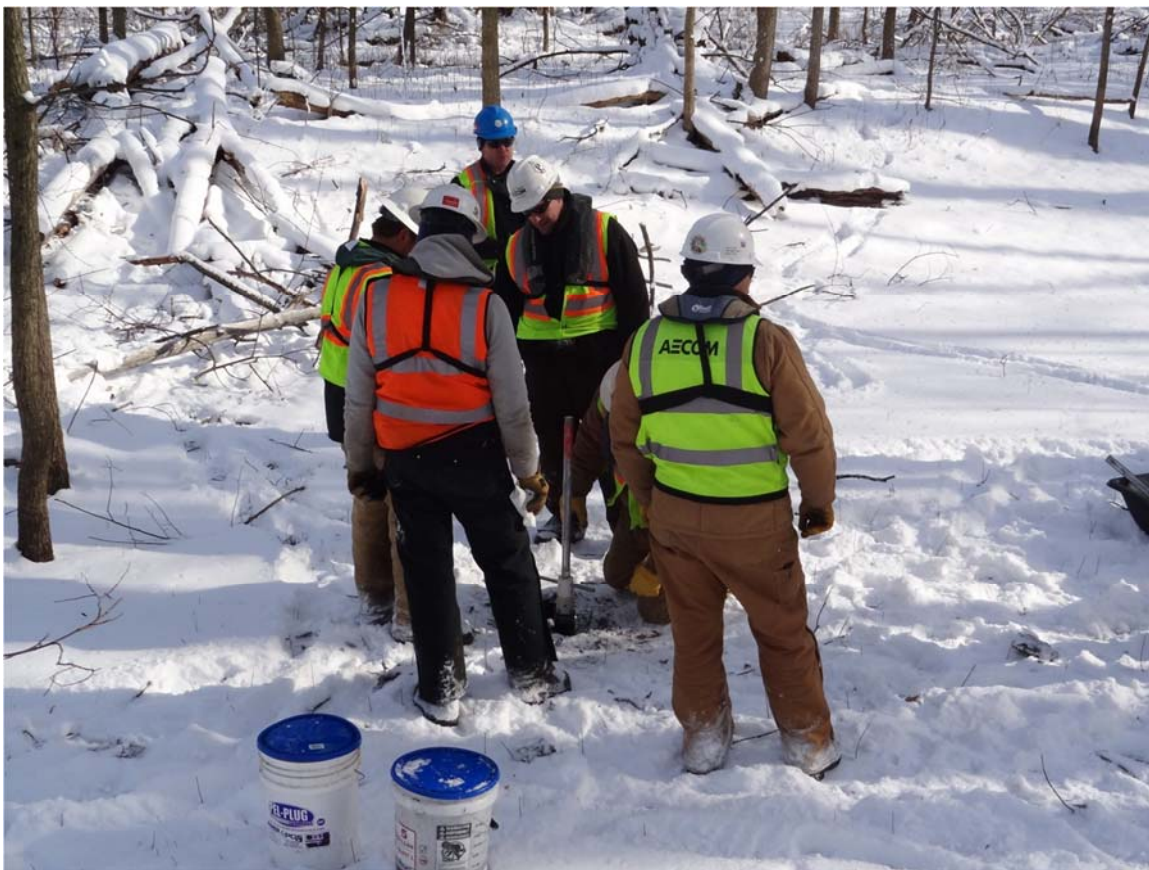
23. MP21.25 RDB overbank oxbow observed the RI crew.
